VHF Direction Finder (VDF)
Operational Test and Evaluation
(OT&E) Integration and OT&E
Operational Test Report

May 1994

DOT/FAA/CT-TN94/12

U.S. Department of Transportation Federal Aviation Administration

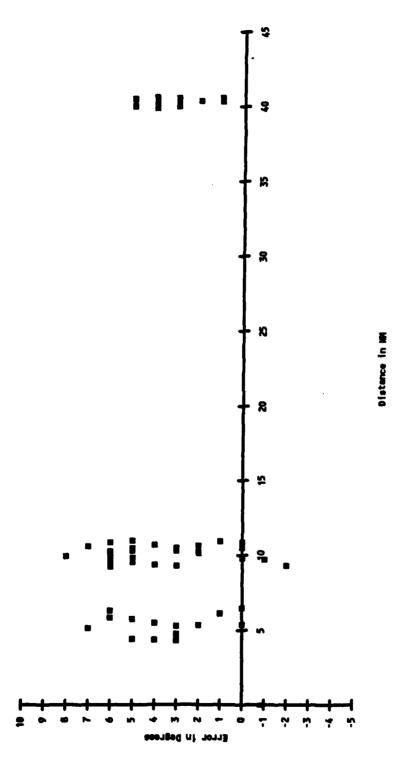
FIGURE 5.3-1. GREEN BAY ERROR AS A FUNCTION OF DISTANCE

General azimuth accuracy of DF system-generated positions was found to be independent of distance within the 40 nmi operational radius. Beyond 40 nmi, the error of the FA-9964 sites becomes unpredictable, therefore, a reported azimuth could be good or unusable. The FA-10121 sites appear to provide useable data beyond 40 nmi, which is possibly a result of a better algorithm for discarding data when conflicting signals arrive at the antenna site. It should be noted that atmospheric conditions, as well as site conditions can bias these long-range results.

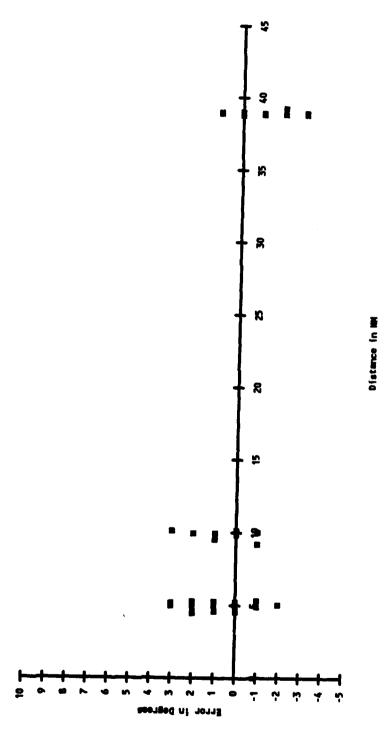
FIGURE 5.3-3. STEVENS POINT ERROR AS A FUNCTION OF DISTANCE

It was also found that transmissions of approximately 1 second in duration were less reliable at the Stevens Point FA-9964 site than at the Green Bay FA-10121 site. A look at the data shows that a single point biases the results, however the point is within expected variation and so there is no reason to discard it. At the Stevens Point FA-9964 site, all data taken at the 2-second and greater transmission durations showed azimuth errors similar between sets. Data from the 1-second transmission duration tests was not included in figures 5.3-1 to 5.3-7 data in order to prevent a slight biasing of the results.

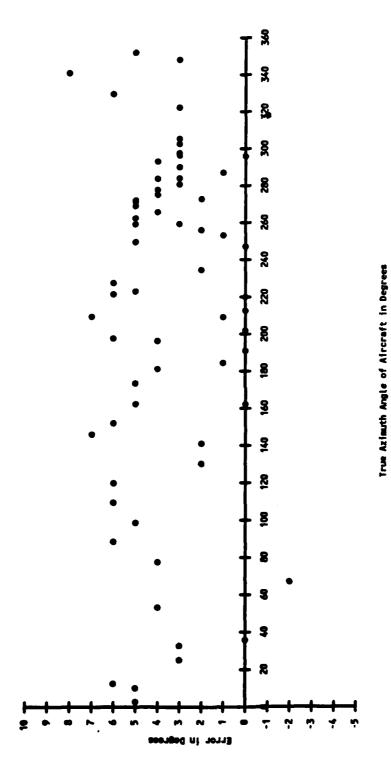
FIGURE 5.3-4. GREEN BAY ERROR AS A FUNCTION OF TRUE AZIMUTH

It can be seen from section 5 of VHF Direction Finder (VDF) Operational Test and Evaluation (OT&E) Integration and OT&E Operational Test Logs and Data, table 5.3-1 and figures 5.3-4 through 5.3-7, that the FA-9964 antennas have lower average error and lower deviations from average than the newer FA-10121s. However, these figures do not take into consideration the different sites of the respective antennas. is plausible that the older FA-9964 antennas are located at more favorable sites or that installation of FA-10121 antenna sites have different siting constraints than the FA-9964 systems; therefore, the FAA would need to identify and correct our siting procedures. It should also be noted that the Green Bay and Marquette FA-10121 antenna errors were heavily biased toward the positive with both having an average error of +4 degrees. If the errors were balanced during commissioning flight inspection, accuracy figures would improve. However, the distribution of errors would remain unchanged regardless of average error. Note that the FA-10121 antenna sites were prepared for operation using surveyed target bearings and that the operational rule for current commissioned DF systems is that flight inspection provides the final authority for course alignment.
